## Construction Laborer Dies After Being Run Over and Crushed by a Grader at a Road Construction Site - North Carolina

NIOSH In-house FACE Report 2002-03

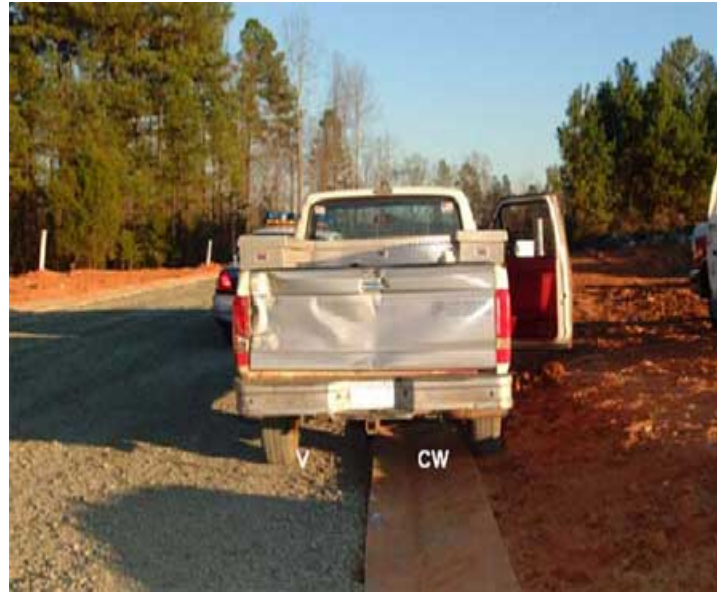
**Photo 1: This photo illustrates the approximate location of the victim (V) and the coworker (CW) at the time of the incident. The tailgate of the truck shows damage that resulted when the grader struck the truck.**

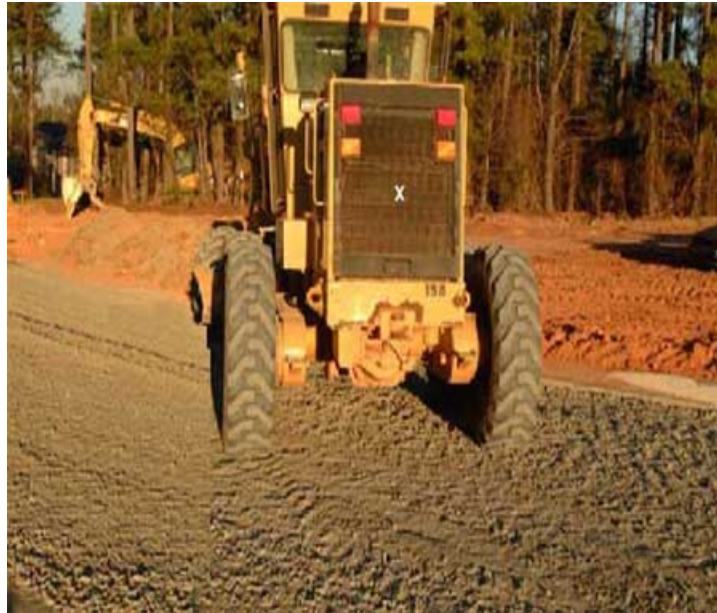
NCOSHA investigators examined road grader #1 (the grader directly involved in the incident). The road grader was manufactured in 1996. According to the construction company owner, he had leased the grader when it was new under a long-term lease from an equipment rental company. He had used the grader for approximately 5 years and had a verbal agreement with the rental company that his company would take responsibility for all minor repairs and servicing which included maintaining or replacing backup alarms. The grader was equipped with a backup alarm ([Photo 2 \(#photo2\)](#)). When the backup alarm was tested by NCOSHA and police department investigators on the day of the incident, the alarm emitted no audible signal.

Grader Operator #1 told NCOSHA investigators that he had notified his superiors that the backup alarm was not working properly 2 weeks before the incident, but it had not been replaced. The grader operator told police and NCOSHA investigators that he did not see the workers or their parked pickup truck because the sun was shining in his eyes. Police investigators determined that visibility was nearly impossible when seated in the driver's seat of the grader and looking backward due to the bright setting sun and the dust- and dirt-covered cab windows and mirrors ([Photo 3 \(#photo3\)](#)). NCOSHA investigators inspected side mirrors that had been installed on each side of the grader by the equipment lender; they were loose and would not stay in place when adjusted.

**Photo 2. This photo illustrates the rear of the grader used at the time of the incident. The backup alarm is positioned behind the grill work and is marked with an X.**

**Recommendation #3: Employers should ensure that equipment is inspected daily and all defective equipment is removed from service until needed repairs have been made.**

Discussion: Employers should designate a supervisor to be responsible for daily preshift equipment checks and for verifying that any problems are corrected. Although equipment may also be inspected by other workers, for example the equipment operator, the supervisor must be responsible for ensuring that inspections are performed daily, that necessary repairs are made, that scheduled maintenance is performed, and that records of all inspections are maintained. Equipment should be removed from service until repairs are made. For example, equipment should be removed from service until a malfunctioning backup alarm is replaced with a functioning audible alarm. According to OSHA standards, earthmoving equipment which has an obstructed view to the rear can be used in reverse gear only when the equipment has in operation a reverse signal alarm distinguishable from the surrounding noise level or when there is an employee available to signal the equipment operator that it is safe to move in reverse (29 CFR 1926.602 (a)(9)(ii). [3 \(#ref3\)](#))

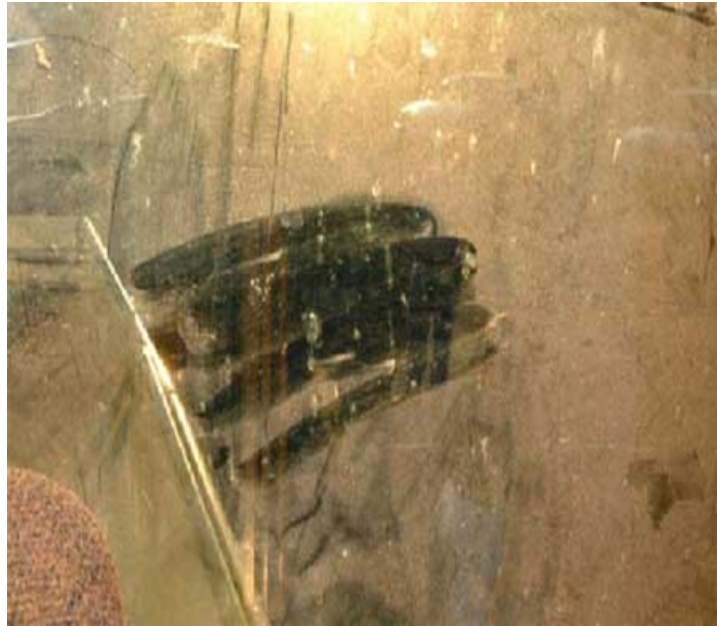
**Photo 3: This photo illustrates the view through the back window from the driver's seat of the grader. Some of the dust was rubbed off, and upon careful scrutiny through the haze, one can barely see a person standing several feet behind the grader.**

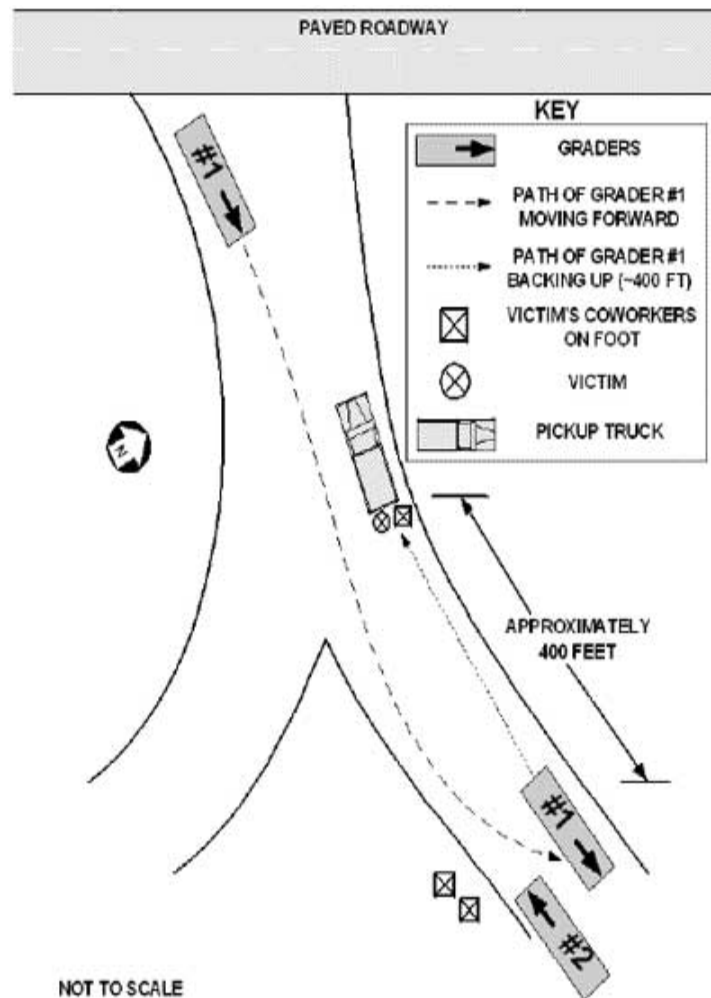
**Figure 1: Figure Illustrates Residential Roadway Schematic.**

The victim's coworker told NCOSHA investigators that he did not hear any warning sounds coming from the grader. Evidence indicates that several pieces of equipment were running near the location of the incident: the pickup truck, grader #1, and a roller, approximately 400 feet away (see [Figure 1 \(#figure1\)](#) for work-site layout).
