## SERVICE BULLETIN

**SUBJECT:** ELECTRICAL POWER – Static Inverter AI<sup>2</sup> Model 1G1000-1A-2170, Part Number 1-002-0102-2170 – Modification.

**TRANSMITTAL:** Service Bulletin 1-002-0102-2170-24-47 Initial Release (Revision 0).

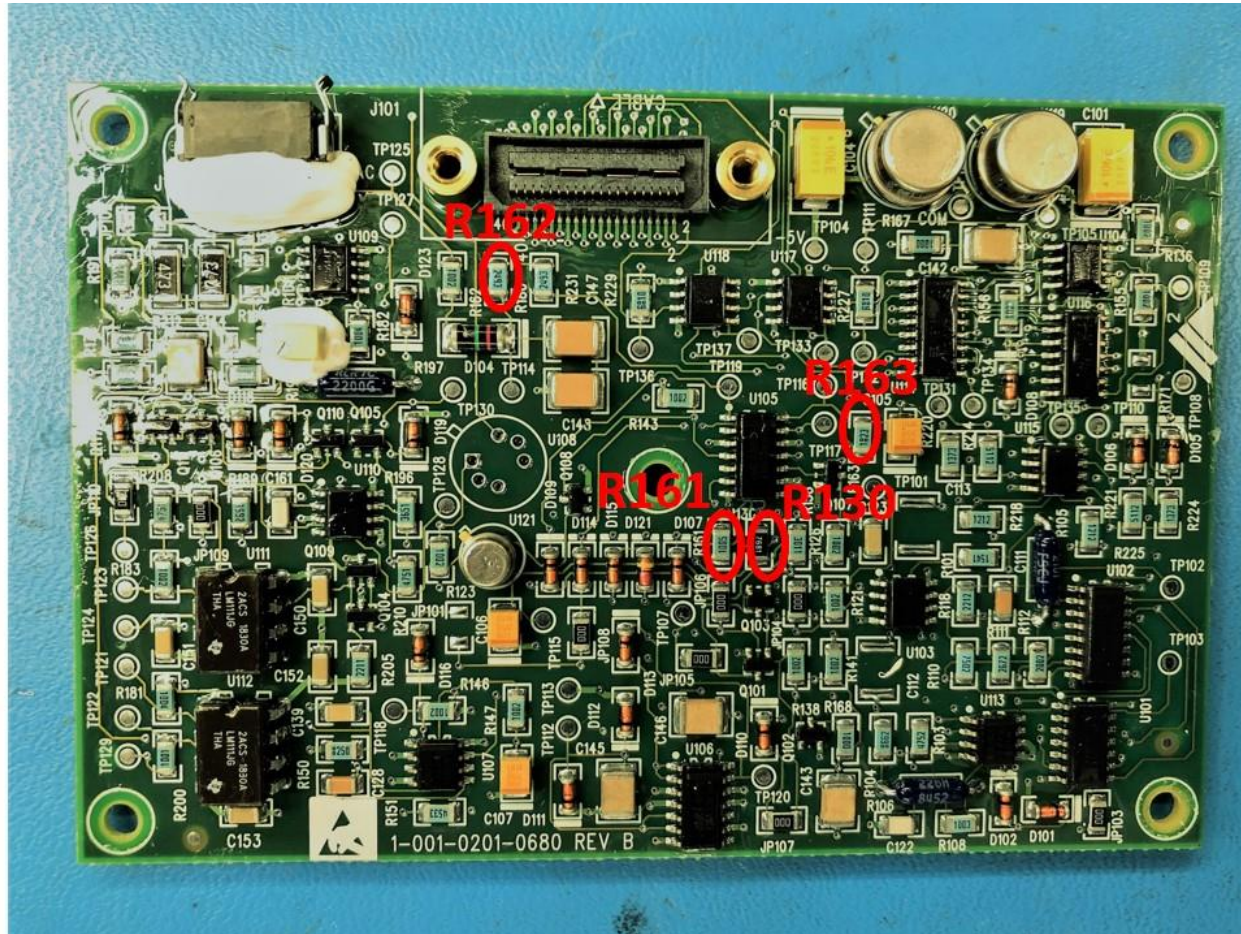
Figure 13 – Inverter board removed

Avionic Instruments has investigated and tested numerous scenarios that could cause a no fault found (NFF) return of the static inverter. The root cause of the NFF returns has been identified as unspecified power interruption to the unit. The power interrupt limits defined by the specification do not cause this problem. However, a power interrupt of a certain duration may cause a race condition within the bias supply leading to a latching fault condition. The latch can only be cleared by recycling power to the unit. At the aircraft level, this unexpected latching fault is falsely interpreted as a static inverter hard failure.

15. Remove (5) screws (5x MS51959-12) from shield. (Figure 10, 11).
16. Remove (2) screws (2x 0404CPP188) from inverter control. (Figure 12).
17. Locate resistors R130, R131 R162 and R163 on the inverter board. (Figure 13). (IPL Figure 26 items 225, 210 and 235).

18. Use solder tool to remove and replace resistors as follows:

Reference #	Original Part #	Replace with Part #
R130	1-001-0662-0023 (7.32k Ohm)	1-001-0662-0025 (7.68k Ohm)
R131	1-001-0662-0023 (7.32k Ohm)	1-001-0662-0013 (2k Ohm)
R162	1-001-0662-0007 (1k Ohm)	1-001-0662-0029 (10k Ohm)
R163	1-001-0662-0040 (68.1k Ohm)	1-001-0662-0129 (182k Ohm)
