Construction Laborer Dies After Falling from Ladder

Michigan Case Report: 05MI163

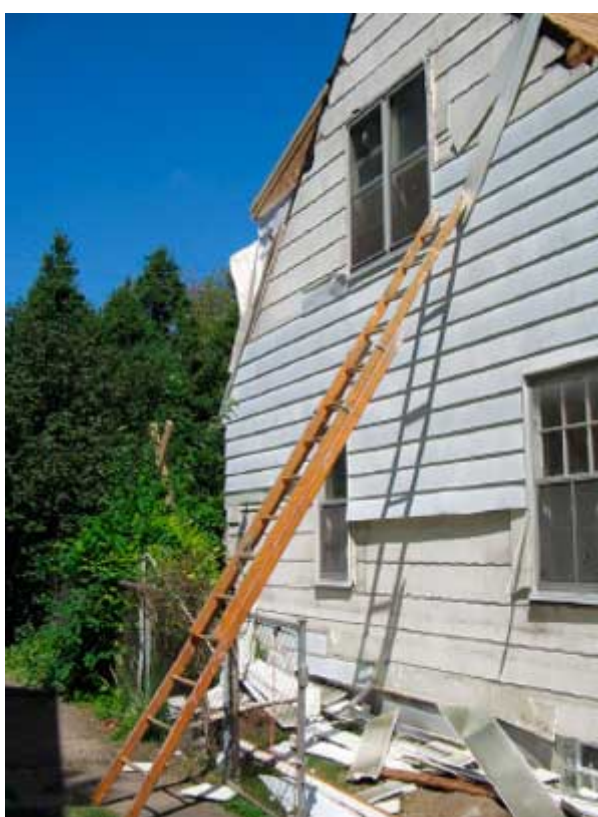
Figure 1. Siding being removed, ladder propped against fence.

The crew arrived early at the worksite, worked all morning, and had just finished lunch. The siding on the west wall within reach of ground level had been removed and dropped on the ground next to the home. To begin the siding removal from near the roofline, the decedent and one of his coworkers placed their ladders against the west wall. The decedent's ladder was positioned south of the dormer window. The other contractor's ladder was one section of an extension ladder and was placed south of the decedent's ladder. The decedent was wearing his tool belt. The decedent and his coworker removed several pieces of siding near the roofline prior to the incident.

Construction employers should consider using scaffolds or other work platforms to work from instead of ladders.

Better work platforms for this construction activity would have been a scaffold or an aerial work platform. Many safety experts recommend that a ladder should be used primarily to climb to or from a work area, not as a work platform. Employers should endeavor to limit the use of a ladder as a work platform. The use of a ladder inherently limits the possible work area of a worker to an arm's length on either side of the ladder. Safe ladder use requires a worker to maintain a three-point connection (two hands/one foot or two feet/one hand) and his/her shoulders within the side rails. The employer should determine if there are safer alternatives to performing a job rather than using ladders.

When possible, instead of using ladders to work from, use scaffolds or an aerial work platform, such as a scissor lift. A larger work area, more stable work platform, and reduced physical stress could be gained through the use of scaffolding or other types of work platforms. This would enable a worker to walk small distances safely and reduce the need for re-positioning a ladder to access a new work area during operations. Because a worker can stand fully upright and use both hands for work procedures, an additional safety factor is obtained with this type of equipment. Also, a larger work surface is available for the safer storage or positioning of tools and materials.

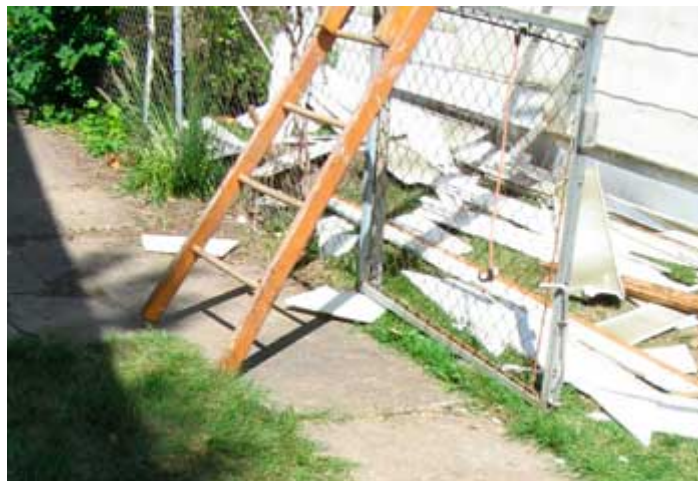
The portable extension ladder that an employee is using to remove aluminum siding from the west side of the house does not have safety feet and is not tied, blocked, or otherwise secured to prevent it from being displaced.

The ladder the decedent was working from was positioned over a cyclone gate and fence of a neighboring home. The ladder was resting on the one of the two concrete driveway tire tracks. The ladder was not secured or blocked in any way to increase ladder stability and did not have safety feet ([Figure 2](#)). A flexible "bungee cord" was hanging from the gate; the reason for its presence is unknown.

Figure 2. Ladder without safety feet on driveway against fence/gate.

1. The ladder was not placed at a safe angle. The best angle for ladder stability is about 75 degrees. Set up straight ladders using the 4 to 1 rule: 1 foot from the wall for every 4 feet of the ladder's working length. The extension ladder length could have been adjusted so that the ladder placement would have been 4:1. If ladders are set up at a steeper angle than 75 degrees above horizontal they are more likely to tip backward in use. If ladders are set up at an angle less than 75 degrees above horizontal they are more likely to slide out from the bottom.

2. The ladder used did not have safety feet nor was the ladder secured. Safety feet and securing a ladder provides stability by minimizing ladder movement. A ladder should always have four-point contact with the working surface, and pressure on each leg should be proportional. The force exerted by the decedent as he was removing the siding may have put a side load on the ladder.

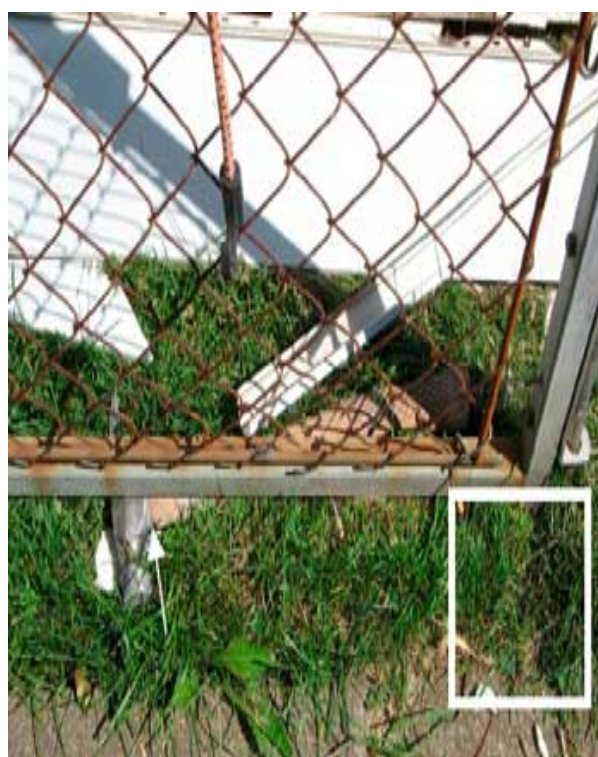
It is unknown how high on the ladder the decedent was standing. He was 6'1" tall, so it is hypothesized that he was not standing on the top three rungs of the ladder to reach above to strip the siding. The police detective stated that the hammer (Figure 3, arrow) was used by the decedent to assist him in removing the siding. The box in Figure 3 shows a divet in the ground caused by either the gate movement from the fall or the decedent/coworker "bracing" the gate by moving it toward the home they were working on.

Figure 3. Hammer used to remove siding.

3. It appears that the gate was being used to help support the ladder. The moveable gate was not secured against movement. The box in Figure 3 highlights a divot that the gatepost made in the grass. It is unknown whether the divot was due to gate movement at the time of the incident or whether the workers pulled the gate toward the home being remodeled prior to the incident in an attempt to "dig" the gate into the ground to minimize gate movement. When positioning ladders, it is important to ensure that all of the supporting structures are stable and strong enough to hold the weight that will be placed on them. Under no circumstances should ladders be supported by structures that may inadvertently cause movement of the ladder.

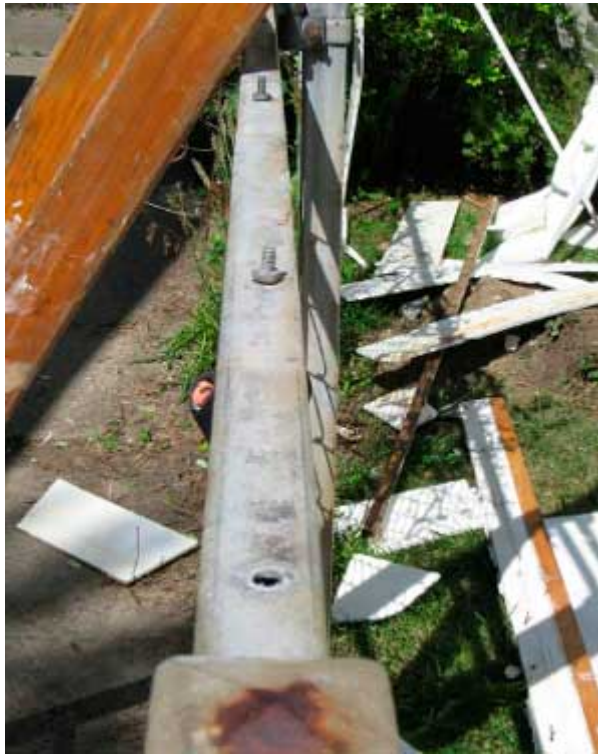
The decedent fell approximately 10 feet. The police report states that the decedent fell approximately 15 feet. MIFACE determined that based on the extended ladder length, the height of the decedent, and his hypothesized location on the ladder, a fall of approximately 10 feet is more likely. When he fell, one of his coworkers was walking with debris to a dumpster located on the driveway on the east side of the home. He heard the decedent moan. He returned to the decedent's work location and found the decedent's midsection folded over the gate. He was positioned next to the ladder. The decedent's head and legs were not touching the ground. His midsection was lying across the end cap of the gate, which was about two inches higher than the gate's top bar and across a small nut and bolt, which was about one inch above the top bar (Figure 4). The decedent rolled off the gate and landed on the ground.

Figure 4. Gate configuration.
