## PROJECT PROFILE: Historic Carriage Barn

RFW  
Historic 1850 Carriage Barn

RWLR  
Waynesville, Ohio

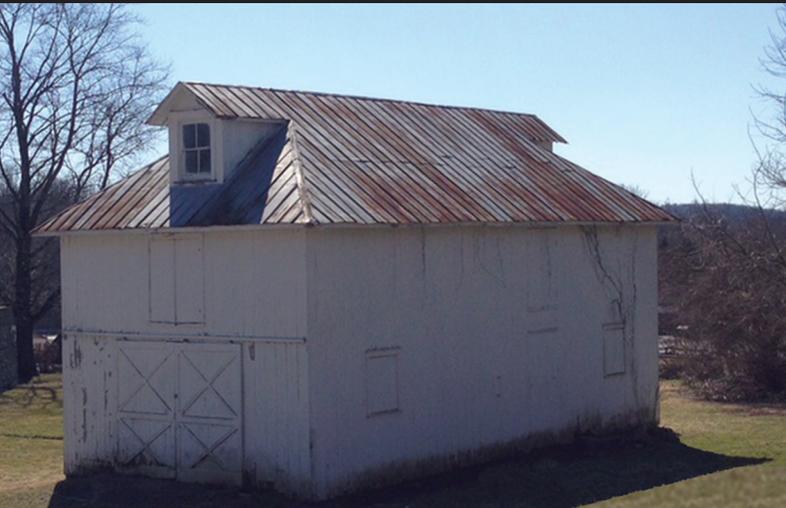
BEFORE

ROHP  
5V crimp metal roof  
experiencing  
corrosion and leaks

Today, the carriage barn is being restored and will eventually become living quarters, but before work could begin on the remodel, the roof issues needed to be addressed first. While not the original roof, the 5V metal crimp roof was very old and in disrepair.

Sams said that his crew pressure washed the existing metal roof and used Karna-Flex to seal the seams and repair areas that were curling. The KARNAK 298 Alumin-R was applied to the metal using a roller. The roof pitch was steep enough that access was a bit challenging so the crew worked using chicken ladders for a safer working environment.

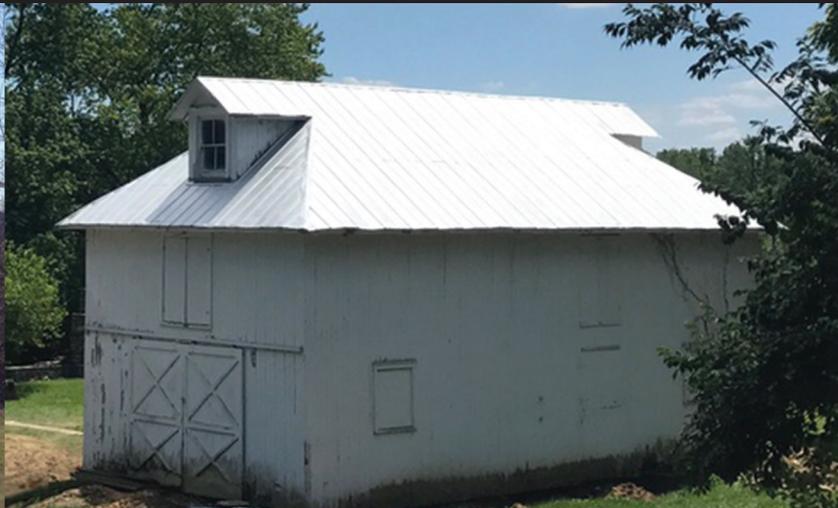
AFTER

ROWLR  
KARNAK 298 Alumin-R
