**Locality:** STRATFORD  
**Place address:** 20 TYERS STREET  
**Citation date** 2016  
**Place type (when built):** Shop, Bakery, Residence  
**Recommended heritage protection:** Local government level  
Local Planning Scheme: Yes  
Vic Heritage Register: No  
Heritage Inventory (Archaeological): No

**Place name:** Bakery (former), Shop and Residence

## Statement of Significance

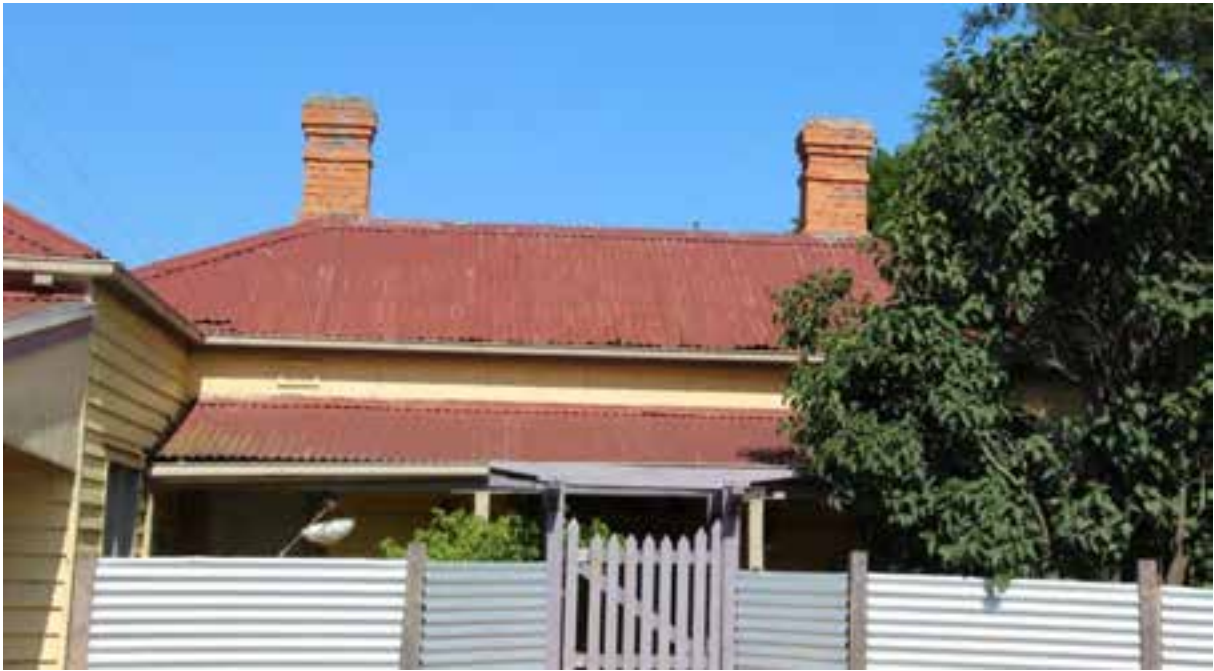
**Figure D1.** The house has an M-hip roof, clad with corrugated iron, and a verandah to the facade which returns on the south elevation. The house retains two corbelled brick (unpainted) chimneys that are constructed of handmade red bricks. A skillion-roof verandah is clad with corrugated iron (painted), supported by stop-chamfered timber posts.

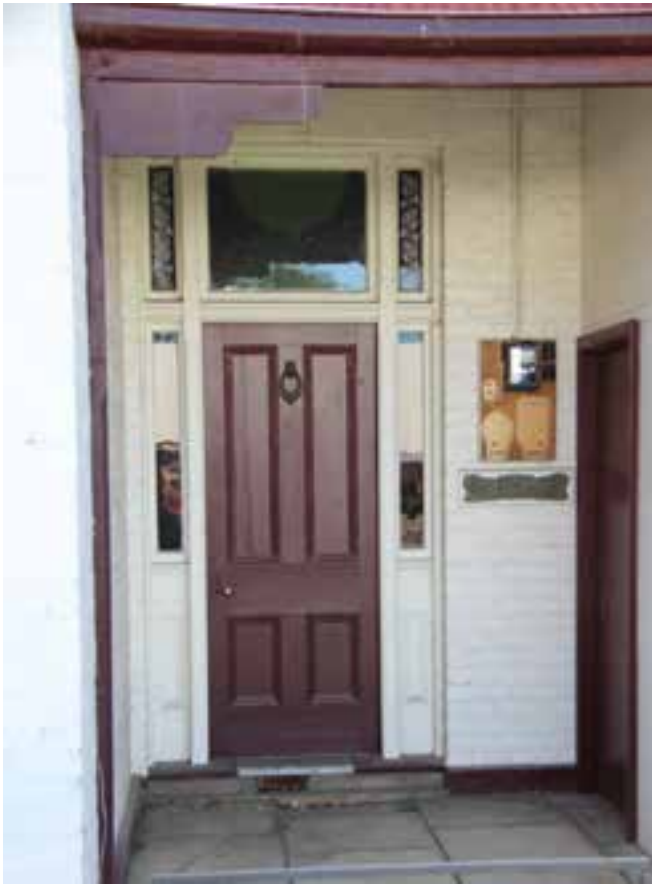
**Figure D3.** The Victorian entrance has a timber panelled door with sidelights above timber panels, and highlights with stained glass; above are radiating brick voussoirs. The bricks have been painted.

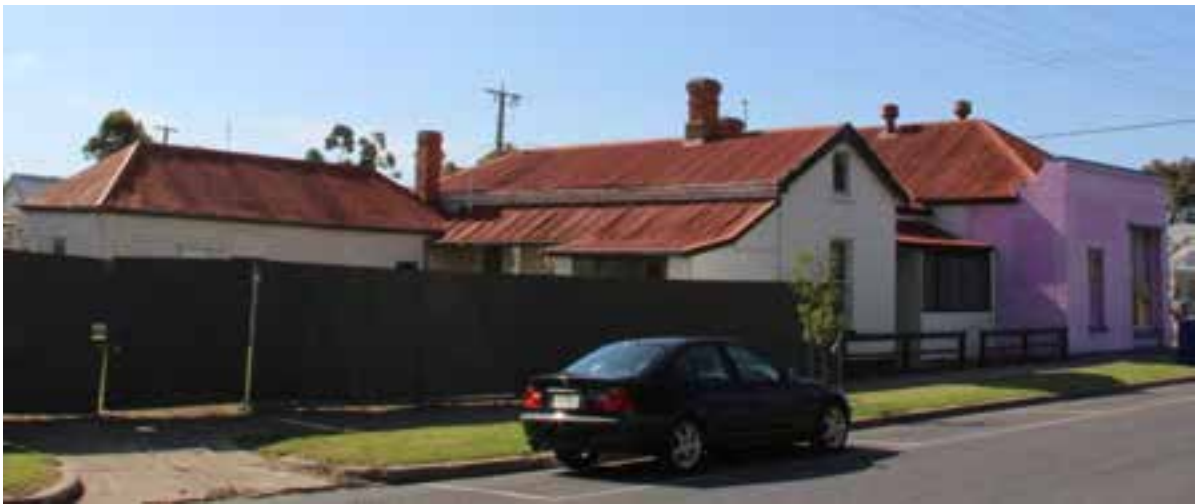
**Figure D4.** View showing the significant shop, residence and early large hipped-roof outbuilding. Off the south elevation of the house is a skillion-roof verandah clad in galvanised corrugated iron.

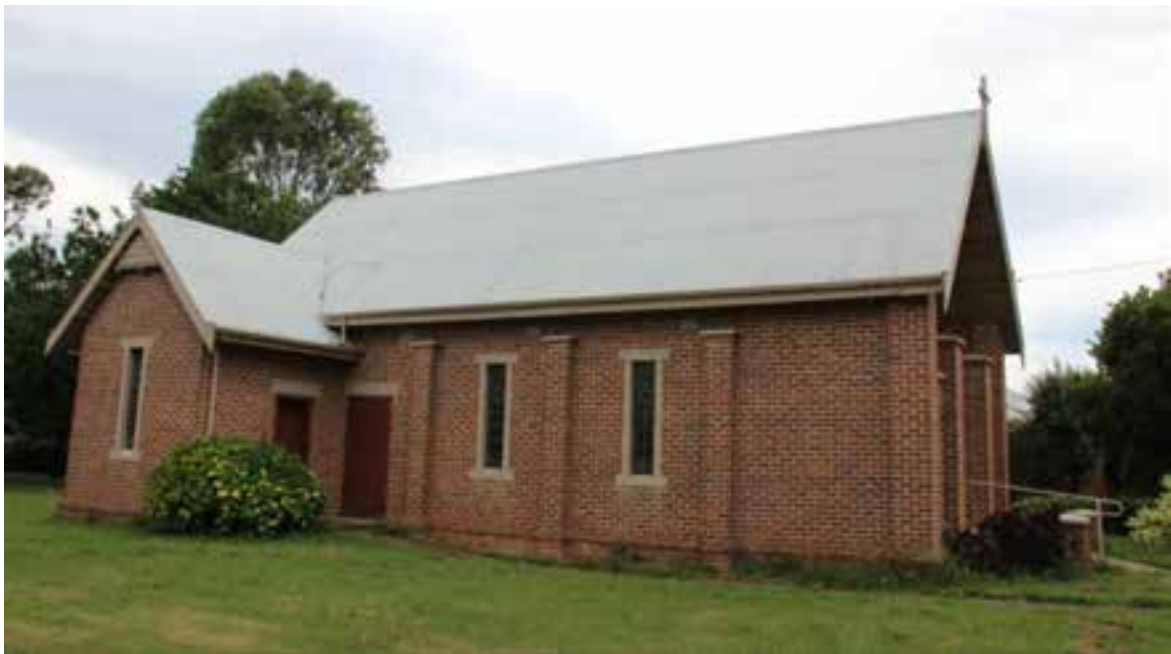
**Figure D2.** The east elevation. The side elevations comprise five bays, broken up by narrow engaged pilasters with a rendered cap. A vestry with a gabled roof projects to the east from the rear of the church, with the same treatment as the nave.

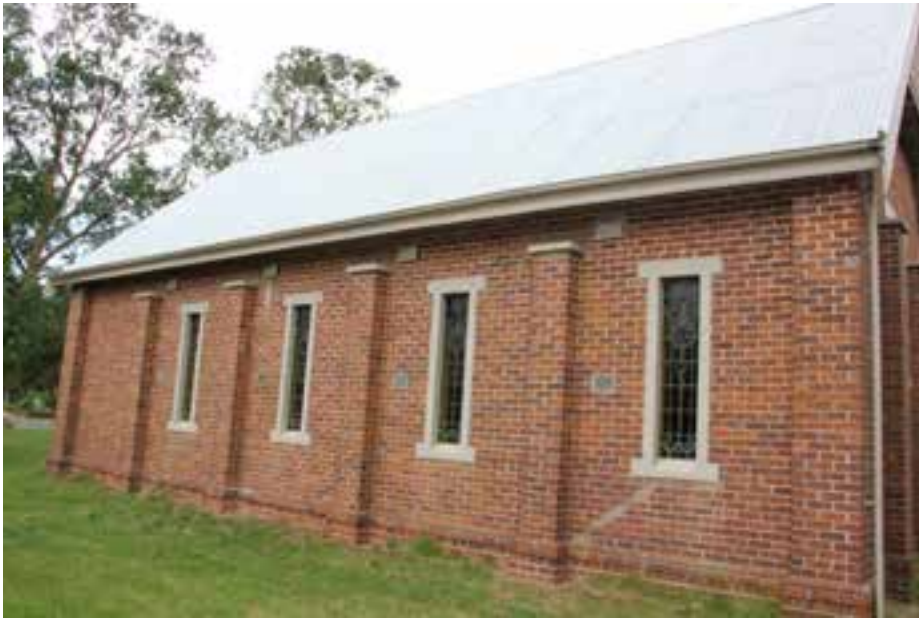
**Figure D3.** The west elevation has four windows (excluding the bay where the porch is, like the east elevation), with the same detail as the east elevation.

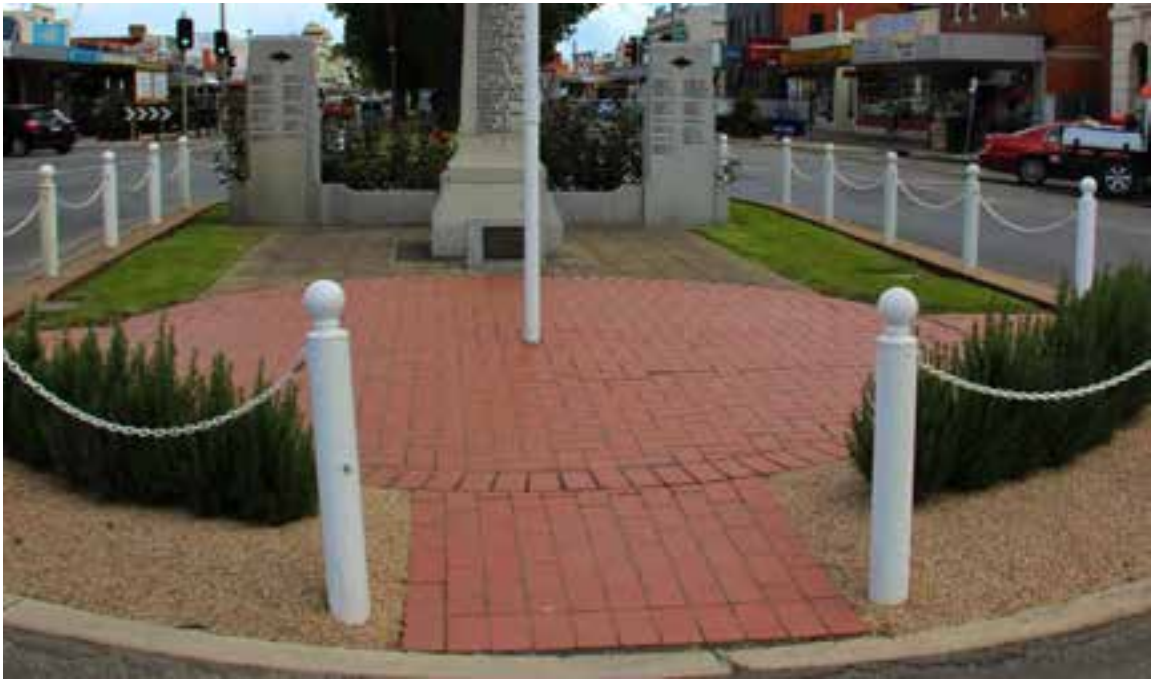
Figure D2. Detail illustrating the inappropriate dominance of the large area of 'recent' red brick.

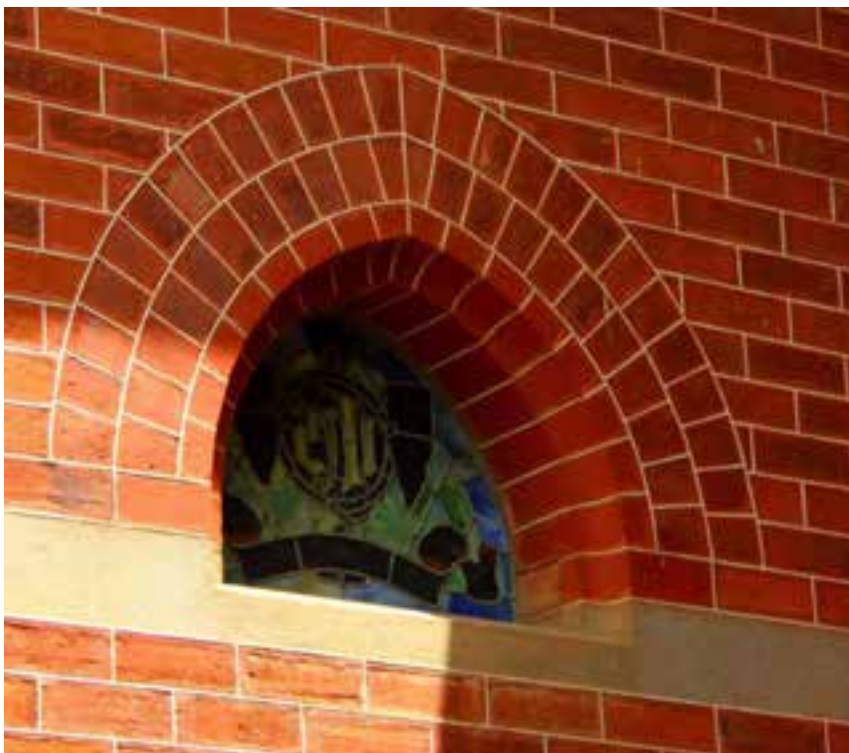
Figure D6. Detail of the exquisite 98 year old brickwork and tuck pointing of the lime mortar, unpainted render and lead lighting, which is all in excellent condition. It should never be painted or treated with any modern sealants. This is testimony to the excellent design, quality of the materials, the builder's skills, and the skills of the craftsmen who created the tuck pointing and lead light by hand.

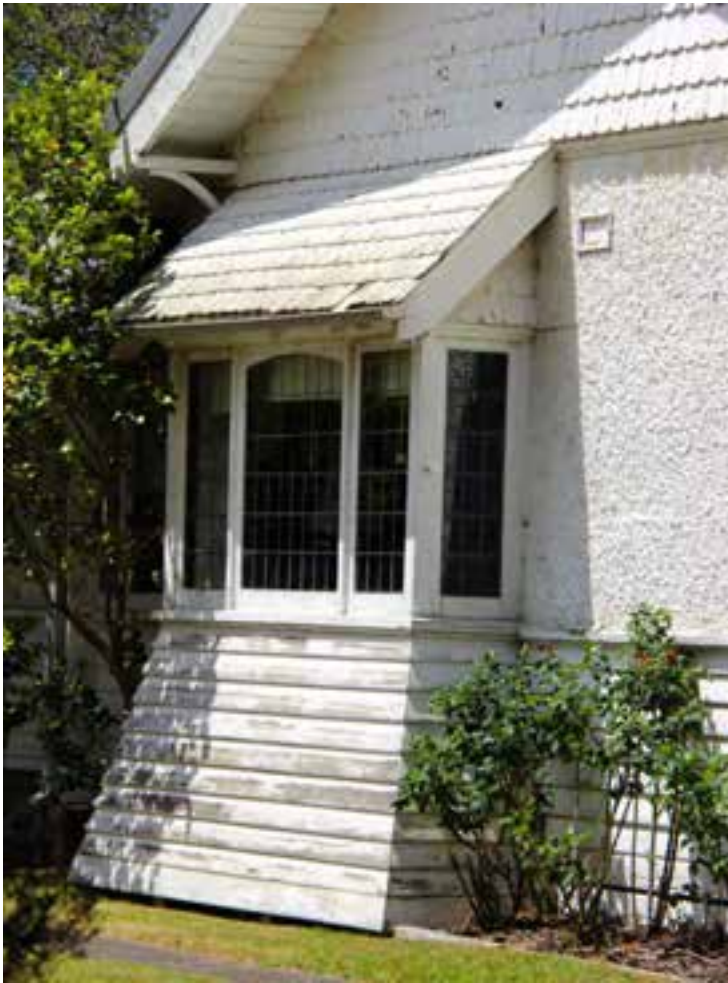
**Figure D2. The projecting box window on the west elevation with a detail of the splayed base clad with mitred weatherboards, geometric leadlight timber windows and shingled roof. Half of the base of the exterior walls is timber, with roughcast render to the top half of the wall.**

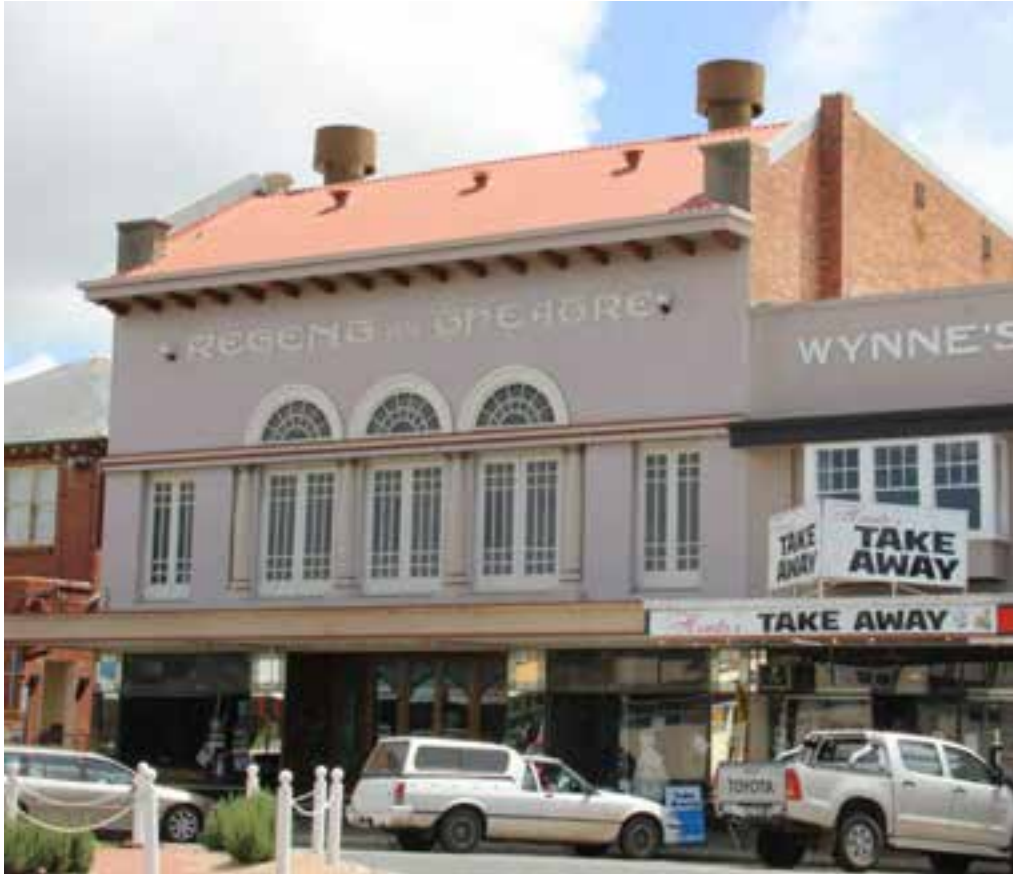
**Figure D1.** The theatre is a red-brick construction, visible on the side elevations where it extends into the gable ends, but concealed by decorative painted render on the front façade. The gable roof is clad in Colorbond deck, which replaced a former tile roof.

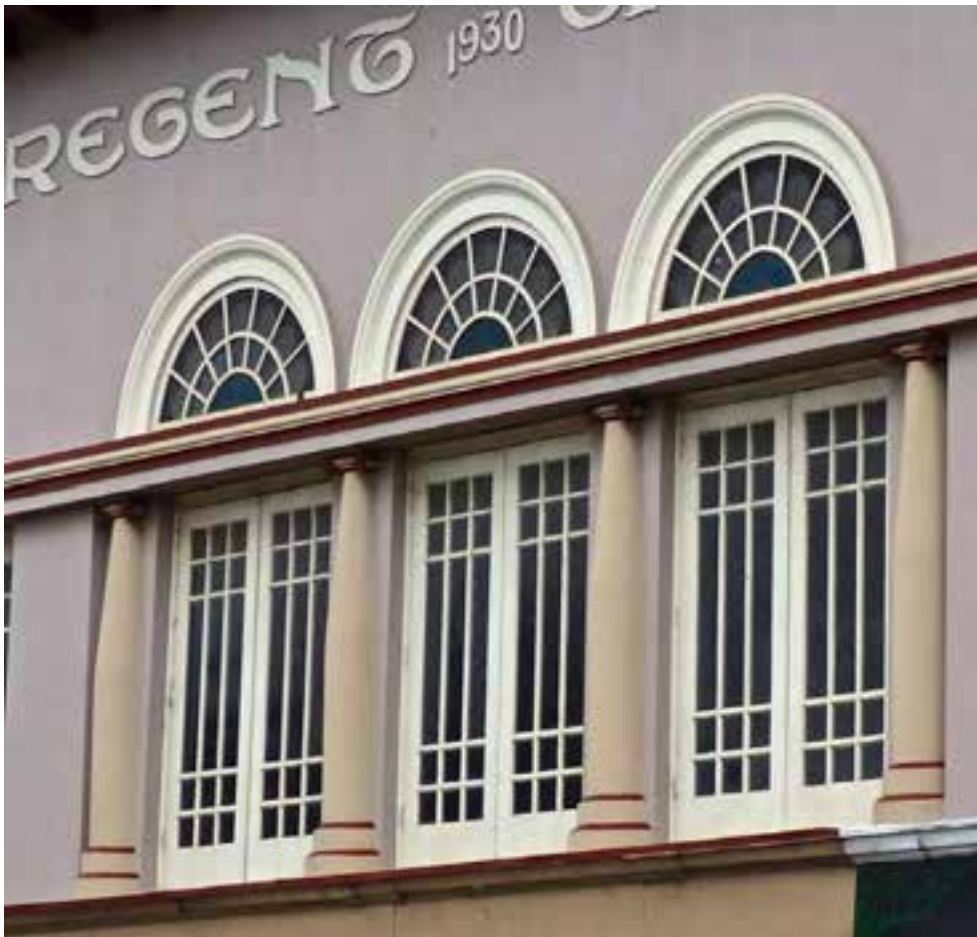
**Figure D2.** Detail showing the four Ionic columns with exaggerated entasis, separating the three pairs of French windows and supporting a moulded entablature with elaborate fanlights above.

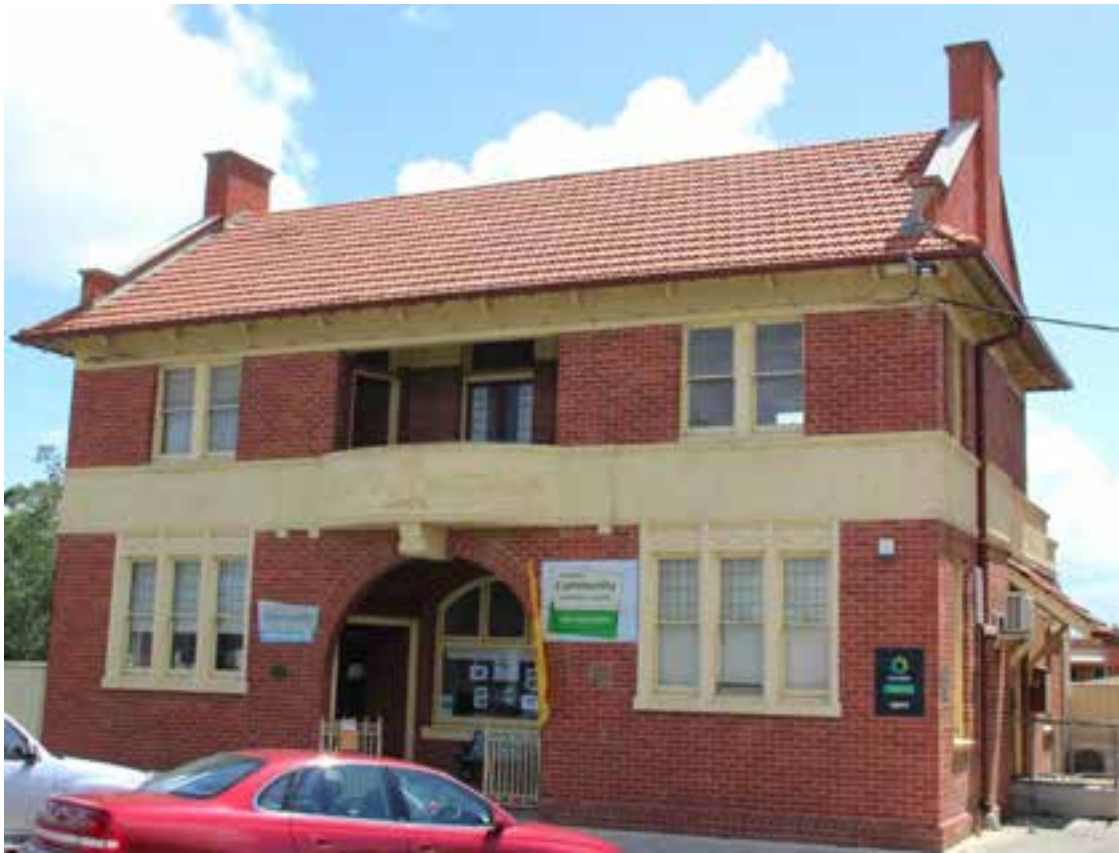
**Figure D1.** The facade of the bank with the predominantly gabled roof clad with terracotta tiles, exposed eaves, a pair of parapeted gable ends which have small hipped extensions for the continuation of the eaves and central semi-circular red brick arched entrance and wide bank of (over painted) render.
