Locality: TINAMBA

Place name: St Matthews Anglican Memorial Church, Memorials & Trees

Project: Wellington Shire Stage 2 Heritage Study

Client: Wellington Shire Council
Author: Heritage Intelligence Pty Ltd

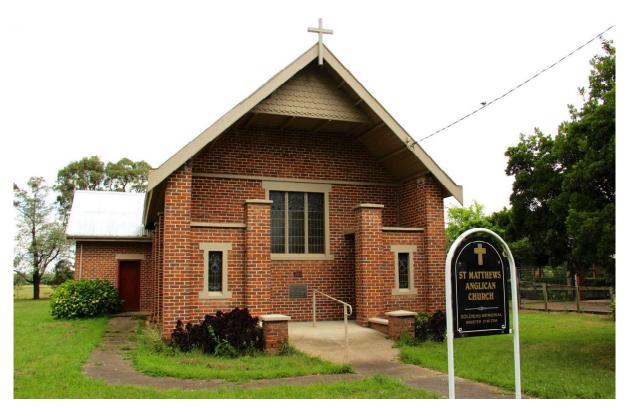
Figure D1. The church is constructed of handmade brown bricks and deliberately contrasting light coloured lime mortar, struck flush with the face of the brick, with a brick plinth and gabled roof clad in lapped corrugated iron (recently painted an appropriate colour). The roof projects forward at the façade, creating a deeply recessed entrance porch for the symmetrical façade.

Figure D1. The church is constructed of handmade brown bricks and deliberately contrasting light coloured lime mortar, struck flush with the face of the brick, with a brick plinth and gabled roof clad in lapped corrugated iron (recently painted an appropriate colour). The roof projects forward at the façade, creating a deeply recessed entrance porch for the symmetrical façade. The deep 'eaves' of the porch are timber lined. A jettied section at the top of the gabled-end is clad with timber shingles. The entrance path is framed by a low balustrade after two squat piers. At the sides of the façade are two 'enclosed' porches formed by two walls (2/3 the height of the side walls) which have a concealed flat roof, covering the timber paneled entrance doors (with unpainted rendered lintels) at each end. The two short walls each have an Art Nouveau leadlight window framed with rendered trim. The recessed wall of the nave has a large three-part (square-headed) window with leadlight. All the leadlight of the church reflects an Art Nouveau influence. The central entrance has a modern metal handrail and concrete path.

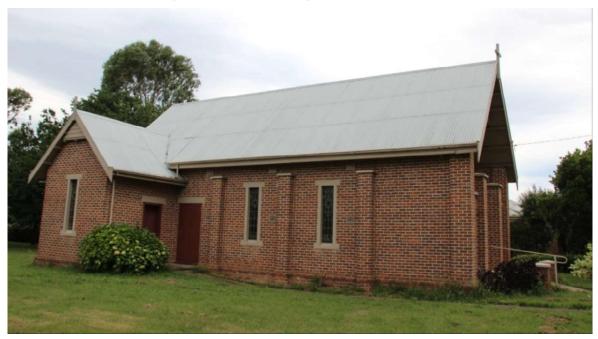
Figure D2. The east elevation. The side elevations comprise five bays, broken up by narrow engaged pilasters with a rendered cap. A vestry with a gabled roof projects to the east from the rear of the church, with the same treatment as the nave.

Figure D2 & D3. The side elevations comprise five bays, broken up by narrow engaged pilasters with a rendered cap. The east elevation has two square-headed windows with leadlight, framed with rendered trimmings, positioned in the two central bays. A vestry with a gabled roof projects to the east from the rear of the church, with the same treatment as the nave. Two timber ledged and framed doors with rendered lintels are located at the rear of the nave, and adjacent at the vestry.

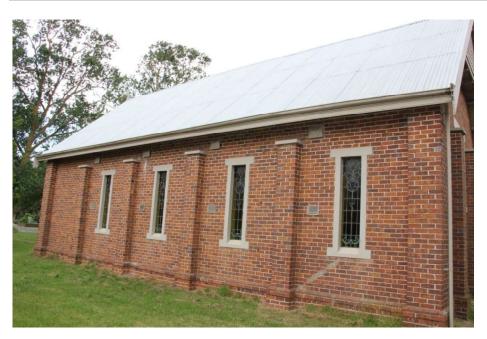
Figure D3. The west elevation has four windows (excluding the bay where the porch is, like the east elevation), with the same detail as the east elevation.

Figure D3. The west elevation has four windows (excluding the bay where the porch is, like the east elevation), with the same detail as the east elevation.

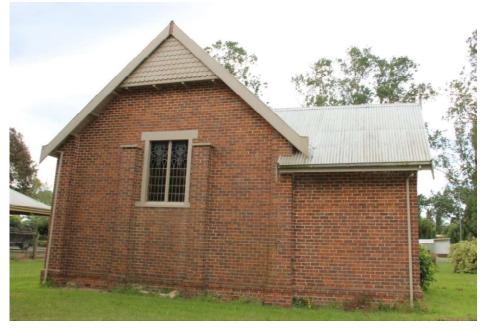
Figure D4. The rear (south) elevation has a jettied section at the top of the gabled end, clad with timber shingles, similar to the facade. Below is a double window of leadlight, flanked by a pair of buttresses.

Figure D4. The rear (south) elevation has a jettied section at the top of the gabled end, clad with timber shingles, similar to the facade. Below is a double window of leadlight, flanked by a pair of buttresses.

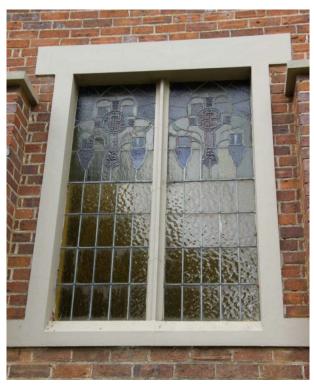
Figure D5. A detail of the windows on the south elevation (at the chancel end) show the geometric leadlight pattern to the bottom portion, and curvilinear detail of the Art Nouveau-inspired leadight to the top.

Figure D5. A detail of the windows on the south elevation (at the chancel end) show the geometric leadlight pattern to the bottom portion, and curvilinear detail of the Art Nouveau-inspired leadight to the top. The window has a rendered sill, lintel and frame at each side.

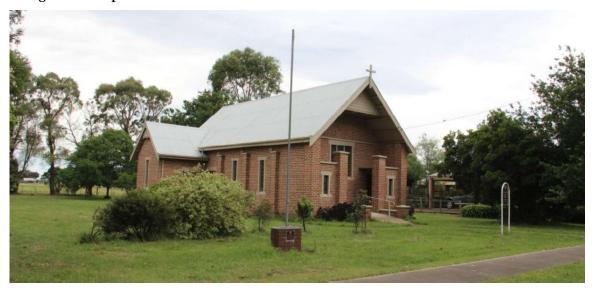
Figure D6. The church is set within a large lot, with a number of exotic trees along the west and south boundaries. A flagpole with a brick base stands to the north-east of the church, near the front boundary.

Figure D6. The church is set within a large lot, with a number of exotic trees along the west and south boundaries. A plaque placed above the foundation stone of the church notes that there was a 'tree plantation' on 25th April 1985 to commemorate Victoria's 150th anniversary.

A flagpole with a brick base stands to the north-east of the church, near the front boundary.

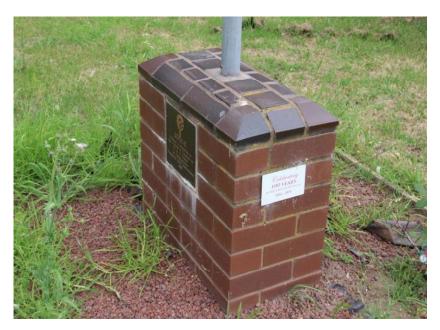
Figure D7. The base of the flagpole holds two plaques. One states that the flagpole was erected and presented to the citizens of Tinamba by W. & C. Fraser to commemorate Victoria's 150th anniversary. A second plaque on the flagpole base reads 'Celebrating 100 years of Red Cross in Australia, 1914-2014'.

Figure D7. The base of the flagpole holds two plaques. One states that the flagpole was erected and presented to the citizens of Tinamba by W. & C. Fraser to commemorate Victoria's 150th anniversary in 1985. A second plaque on the flagpole base reads 'Celebrating 100 years of Red Cross in Australia, 1914-2014'.

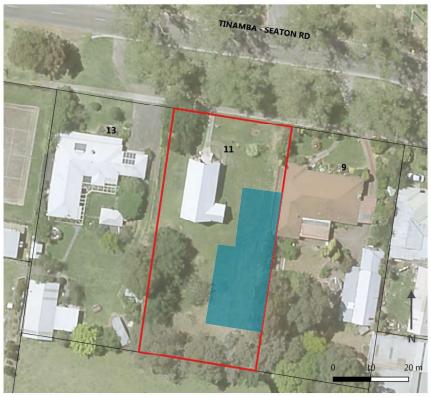
NOTE: The blue shaded area is the preferred location for additions and new development:

- 2.1. New structures should be restricted to the rear of the property, allowing the memorial trees plenty of space to grow, as shown in the blue polygon on the aerial map.
