Tube & Weld

Detachable Hose Connection

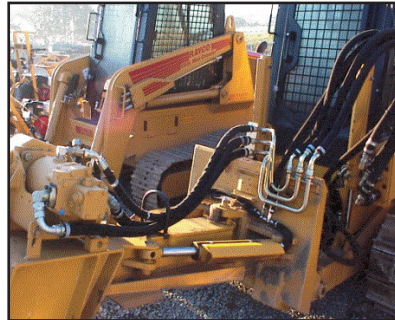
Figure 1. Solution

Solution: After exchanging engineering data including drawings and specifications, it was decided that the best option to streamline the unit would be to design and install a kit assembly that utilized SAE hydraulic tubing for stability and a shortened hose assembly to maintain flexibility.

Result: Although the build cost increased, the aftermarket serviceability was greatly improved. In fact, estimates show that a one-time replacement of the hose assembly under the old design would have cost more than the kit assembly under the new design. Therefore, our tube assemblies improved the prototype in three key aspects: lower repair costs, increased safety and better serviceability.
